EIFS INSPECTION REPORT

Date: xx/xx/2007

Inspection Address: 1234 51st ST Ct, Mill Creek, WA 98012

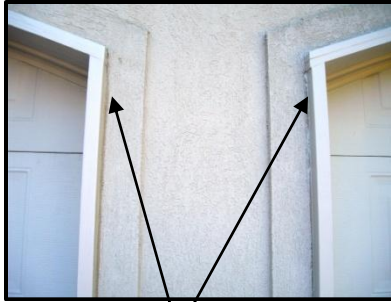
The windows and doors on this structure do not have the recommended ½-inch gaps around them. The sealant used around the windows and doors were not the recommended type, which has caused the sealant to crack and pull away from the substrate. Recommend having a certified EIFS contractor repair the EIFS so that there are proper gaps around the doors and windows and other areas where the EIFS contacts dissimilar products. After gaps are placed at recommended widths, these gaps must be sealed with the proper backer-rod and sealant.

No gaps between the door trim and EIFS

- Install proper gaps around the doors and windows and other areas where the EIFS contacts dissimilar products. After gaps are installed at recommended widths, these gaps should be sealed with the proper backer-rod and sealant.

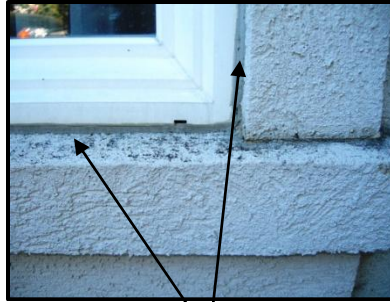
No gaps between the windows and EIFS

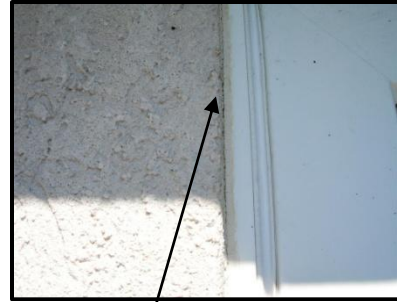
No gaps between the windows and EIFS

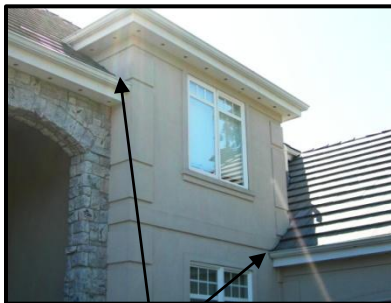
In general, the flashings were properly installed, except where the lower roof abuts the upper wall. The diverter flashings at this location are too short, which has allowed water to flow down the wall. A moisture meter reading taken below the diverter flashing, where the garage roof abuts the house wall, revealed an elevated moisture content of 22.7%.

Diverter flashing locations

- Have a licensed roofing contractor repair the diverter flashings and then have a certified EIFS contractor repair the EIFS around the new diverter flashings to prevent future water damage

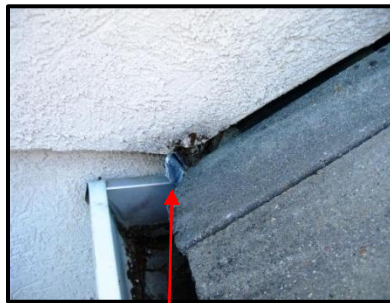
Diverter flashing is too short

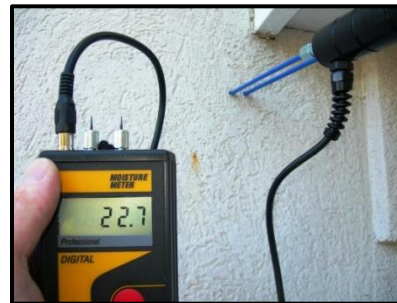
Any moisture reading above 19% indicates that there is a possibility of moisture damage to the plywood sheathing. It had been dry and sunny for approximately a week before the inspection, which indicates a prolonged presence of moisture in this area. Recommend having a licensed roofing contractor repair the diverter flashings and then have a certified EIFS contractor repair the EIFS around the new diverter flashings to prevent future water damage.

Elevated moisture reading

The WWD only identified one area with an elevated moisture reading. This area, the wall beneath the diverter flashing where the garage roof abuts the house wall, was subsequently probed with the direct-contact moisture meter, which indicated a reading of 22%.

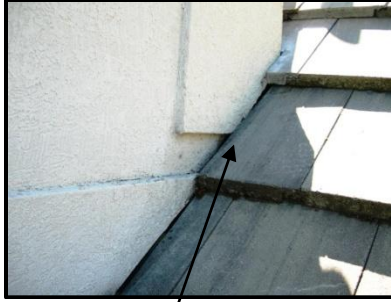
The EIFS should terminate a minimum of 2-inches above the roofing material. However, the EIFS on this house extends below the roofing material, which leaves the potential for water to wick up the bottom of the EIFS. Recommend having a certified EIFS contractor cut the bottom of the EIFS so that it is a minimum of 2-inches above the roofing material. After the EIFS has been cut the bottom edge should be properly backwrapped.

Roofing material is higher than the EIFS

- Trim the bottom of the EIFS so that it is a minimum of 2-inches above the roofing material. After the EIFS has been cut, the bottom edge should be properly backwrapped.

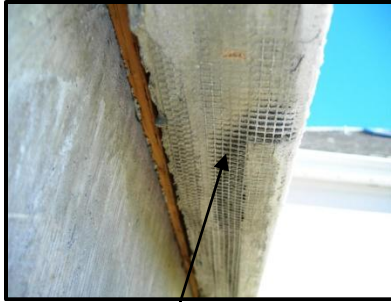
The bottom edge of the EIFS should be backwrapped to protect the bottom edge and to prevent water from wicking up the EIFS. In many areas, there is inadequate basecoat covering the mesh. Recommend having a certified EIFS contractor apply additional basecoat to the bottom edge of the EIFS.

Inadequate basecoat over mesh

- Apply additional basecoat to the bottom edge of the EIFS where basecoat is inadequate.
- Remove all the vegetation that is within 12-inches of the house, including the ivy growing behind the EIFS on the side of the house.

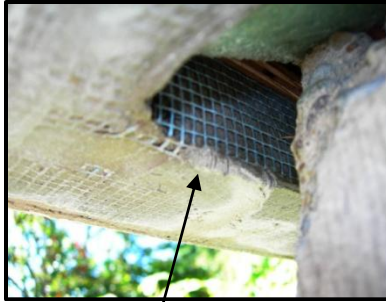
Inadequate basecoat over mesh

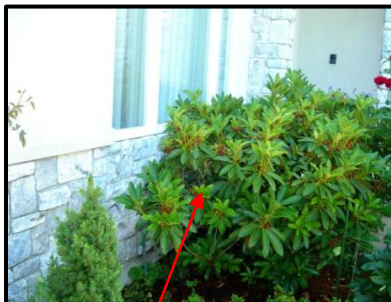
Heavy shrubbery and trees growing against the EIFS decrease light and ventilation, and reduce drying potentials. Therefore, landscaping should be regularly trimmed and maintained to minimize contact with EIFS. Recommend removing all the vegetation that is within 12-inches of the house, including the ivy growing behind the EIFS on the side of the house.

Vegetation against the EIFS

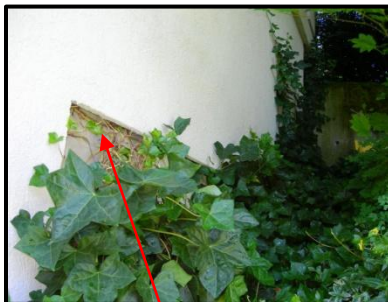
Ivy growing behind the EIFS

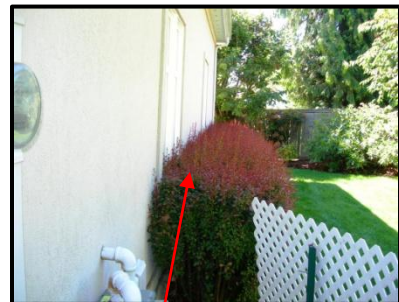
Vegetation against the EIFS

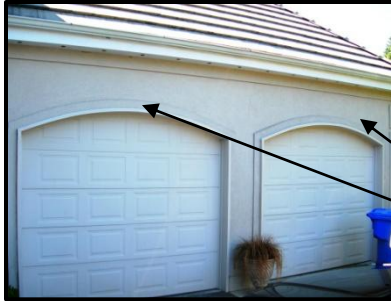
No metal flashings were installed above the garage doors and the windows. The windows are a vinyl type, which some builders consider self-flashed. However, current codes require flashing to be installed over this type of window because the industry has found that the nailing flange on this type of window does not act as a proper window flashing. Ideally, new flashings should be installed above all the windows and doors.

No flashing above the garage doors

- Ideally, new flashings should be installed above all the windows and doors
- Create a sloped surface on all horizontal surfaces on architectural accents.

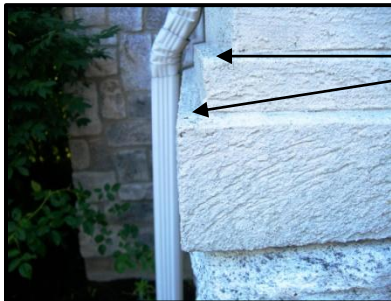
Architectural accents must have sloped upper edges so that water drains off of them properly. The horizontal band trim, window trim and garage door trim are not properly sloped along the top edge. This creates the potential for water to pond on these surfaces, which increases the potential for water intrusion. Recommend having a certified EIFS contractor create a sloped surface on all the horizontal surfaces.

The horizontal surfaces on the entire house are not sloped

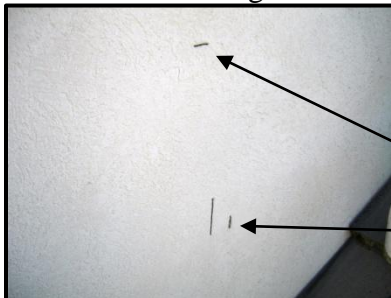
On the wall above the garage, next to the furnace flue pipes, there are several cuts in the EIFS. Recommend sealing these cuts properly.

Several cuts in the EIFS material

- Seal all cuts and damage, including the following areas:
 - The cuts on the wall above the garage, next to the furnace flue pipes
 - The small hole at the edge of the main balcony

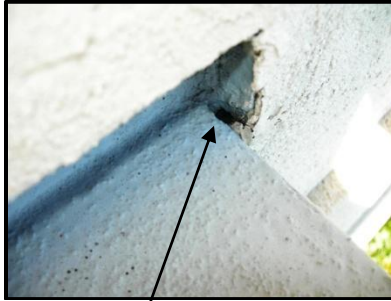
Should seal hole at the balcony

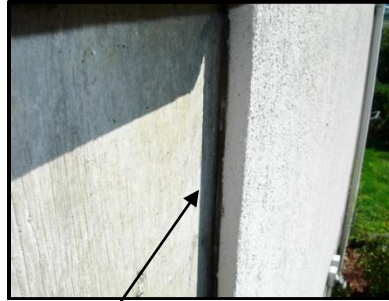
Should seal along the foundation

- The terminations of the EIFS at the foundation where the foundation steps up
 - The tops of all the light fixtures and electrical outlets
 - All pipe penetrations through the EIFS

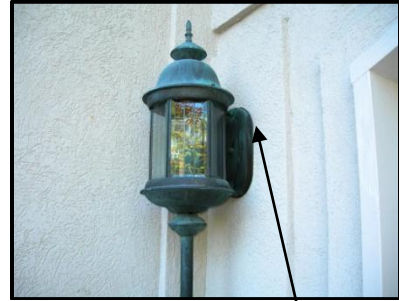
Should seal above all the light fixtures

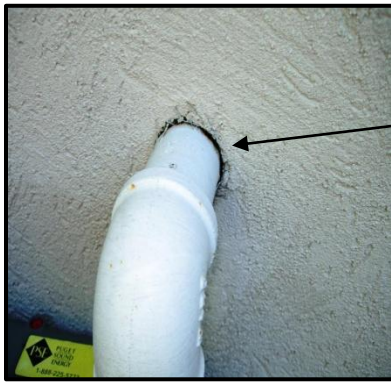
Should seal around the pipe penetrations
