## **PROPERTY CONDITION ASSESSMENT**

**Date:** xx/xx/2007

**Inspection Address:** 1234 51<sup>st</sup> ST Ct, Mill Creek, WA 98012

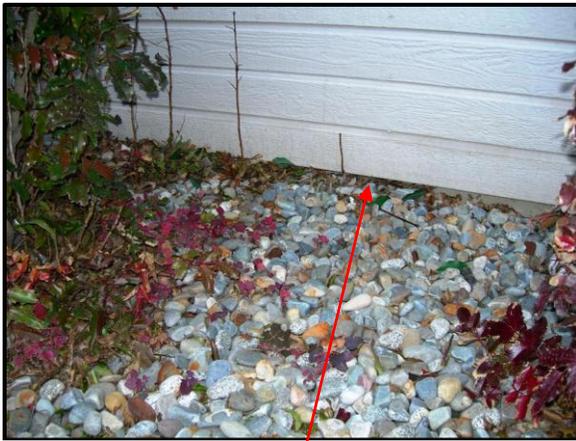
- 1.2. In several areas, the soil to siding clearance is below the minimum requirement. This is a conducive condition to wood destroying organisms. Soil to siding clearance should be a min. of 6 inches.

Soil is too close to the siding

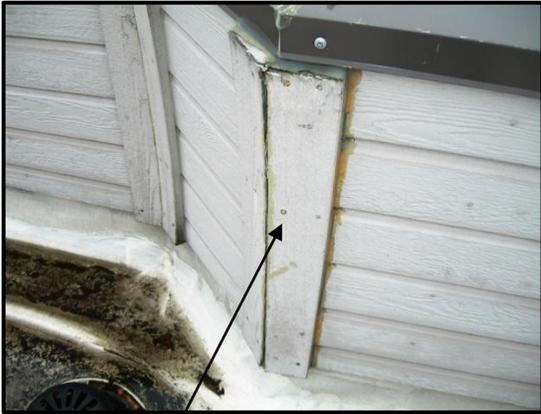
- 3.2.1 Due to improper fastening, many pieces of siding are buckling and pulling away from the building.
- 3.2.2 Most of the nails that were used to fasten the siding were driven too deep, which breaks the surface of the siding and allows water to contact the unprotected interior of the siding, which causes decay.

Decayed siding

Recommend re-securing or replacing the buckled pieces of siding, installing metal flashing above the windows and wall heaters, replacing the siding that are too short to reach the corner boards, replacing the siding on the parapet walls, and replacing all swollen corner

boards. In addition, all the nailheads that penetrate the siding and all gaps around the windows and where the brick meets the siding should be caulked. After these repairs are completed, the exterior of the building should be re-painted.

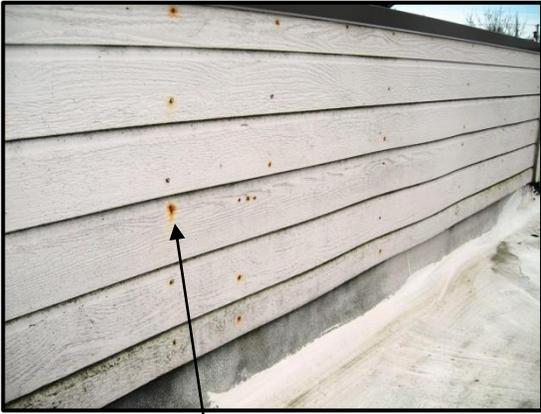
- 3.2.4 There are several areas where the siding was cut too short to reach the corner boards. The resulting large gaps were filled with caulking.
- 3.2.5 The siding and trim boards on the parapet walls above the flat roof are decayed and require replacement.

Siding on the parapet walls needs to be replaced

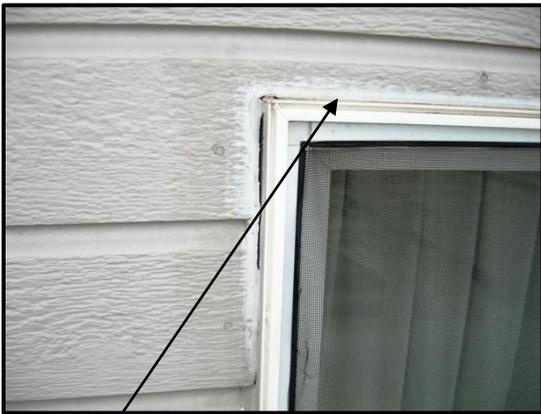
- 3.2.6 There are large gaps between the siding and brick walls that should be sealed to prevent water damage to the wall materials.
- 3.2.7 There is no metal flashing installed above any of the windows or wall heater penetrations and the caulking in these areas is cracking. This has left gaps around the windows for water to penetrate the wall materials.

No flashing above the windows

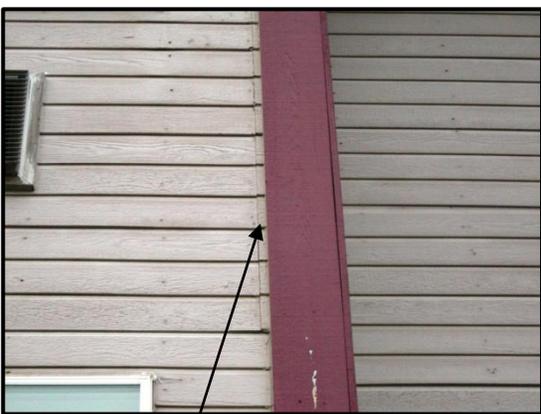
Siding was cut too short (poor installation)

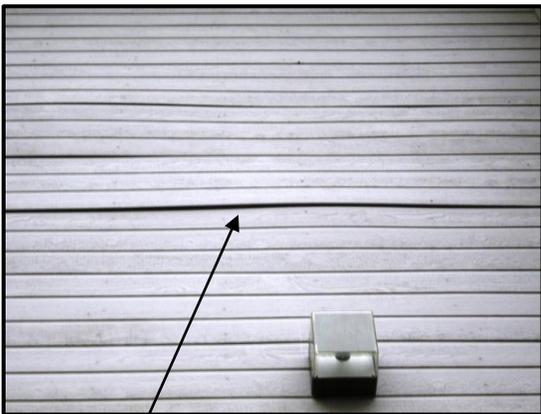
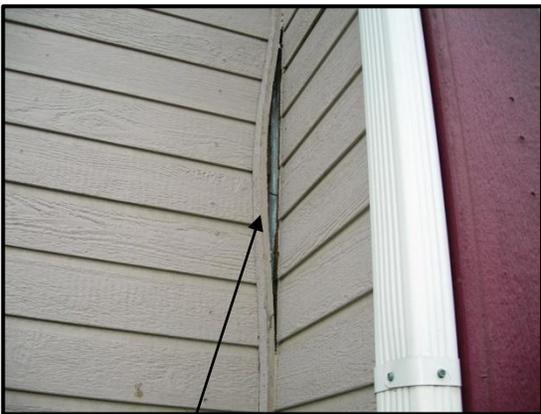
Buckled Siding

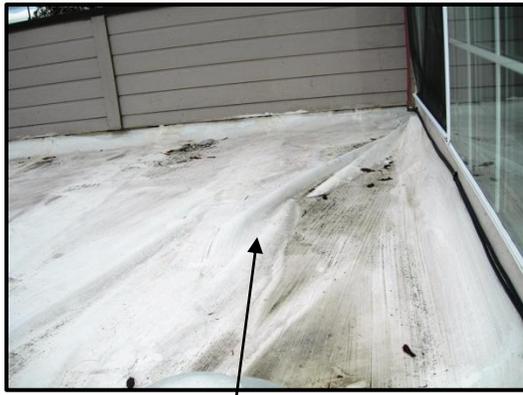
- 4.10 The flat roof section was poorly installed at the time of the original construction. This is indicated by the large ripples in the roofing material. A thermal image scan was performed on the main lobby ceiling and the swimming pool room ceiling, which are both directly below the above-mentioned flat-roof section.

Rippled roofing material (poorly installed)

Although there were no visual signs of moisture damage to the ceiling materials in either of these rooms, the thermal scan detected a temperature difference in the ceiling material above the front desk area and in several locations in the pool room ceiling. This indicates that either there is missing insulation in these areas or the ceiling insulation is wet. Due to the locations of these temperature differentials, all being directly below the above-mentioned poorly installed flat roof section, there is a good possibility this indicates wet insulation. Recommend having a licensed roofing contractor evaluate the flat roof section and make all necessary repairs.

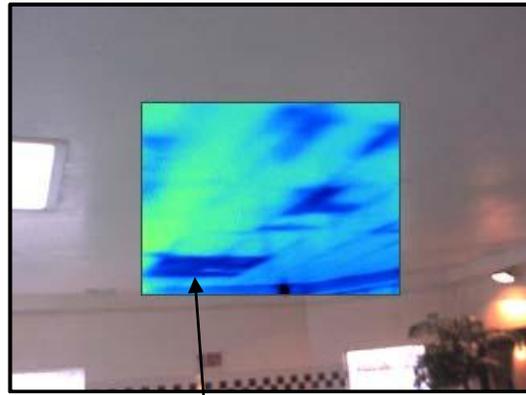
Thermal Scan of pool ceiling (blue areas were verified as wet)

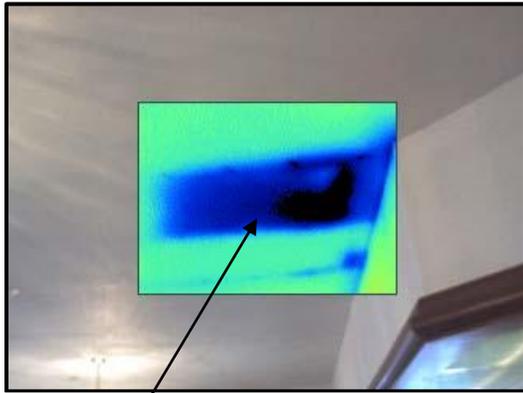
Thermal Scan of lobby ceiling (blue areas were verified as wet)

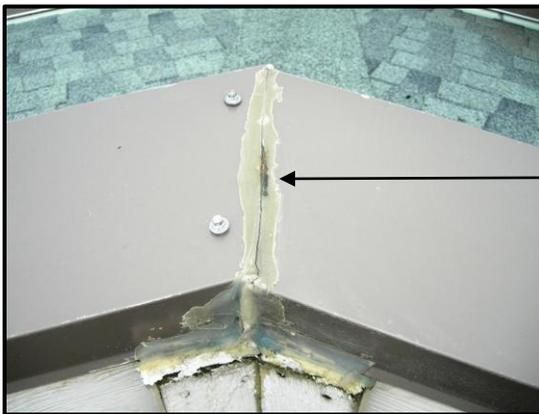
4.11 The seams of the metal caps on the parapet walls should be resealed.

Re-seal the parapet wall flashings

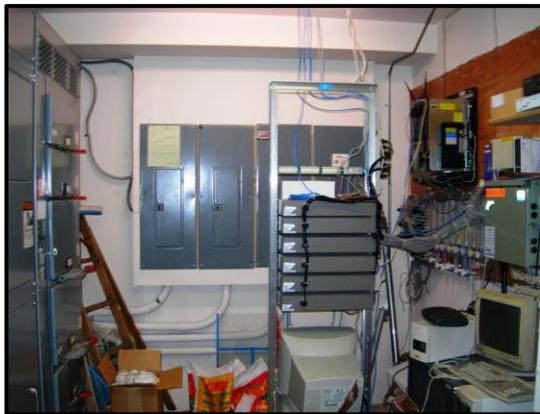
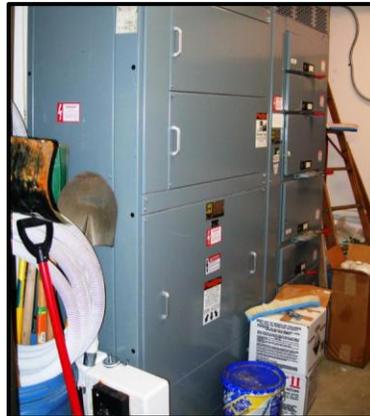
- 5.2. The electrical room is currently being used for storage. This presents a hazard for people working on the electrical equipment and is a fire hazard if flammable materials are stored in this room. Recommend removing the stored items from this room.

Remove all storage items from electrical room

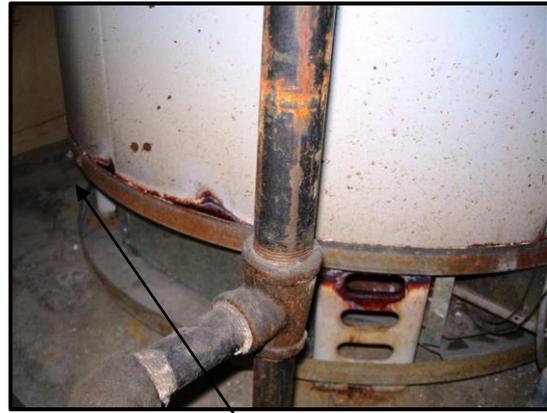
Year	Size	Location	Condition
2005	100 gallon	Laundry Room	Acceptable
1996	100 gallon	Laundry Room	Acceptable (mid-span in useful life)
1996	100 gallon	Laundry room	Leaking and needs to be replaced
1996	75 gallon	Laundry room	Acceptable (mid-span in useful life)

Water heater #3 is leaking

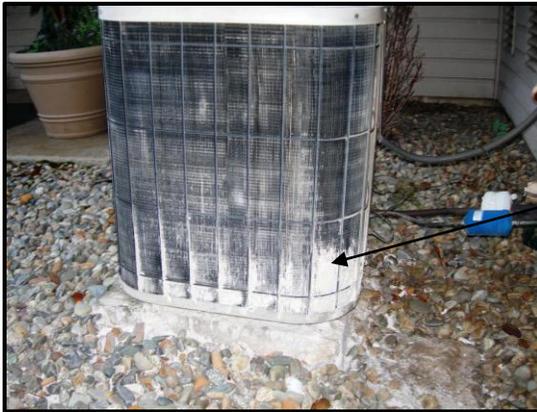
- 7.9 The condensing coil unit at the front of the building is contaminated by laundry lint, and should be cleaned. Recommend re-locating the condensing coil or relocating the dryer vent to prevent the dryer lint from discharging directly into the fins of the condensing coil.

Clean the condensing unit

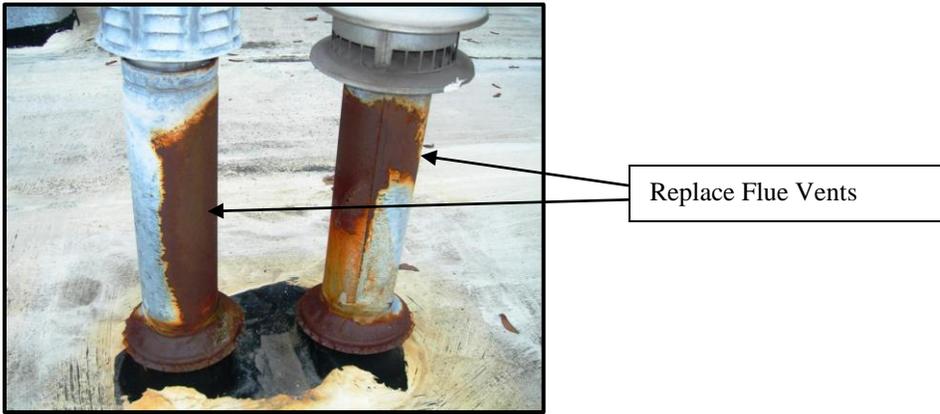
- 9.5 The metal flue pipes for the pool and spa heaters, located on the flat roof section, are rusted through and should be replaced.
