INSPECTION REPORT

INSPECTION DATE
9/9/2007

Report File: Sample Home Inspection

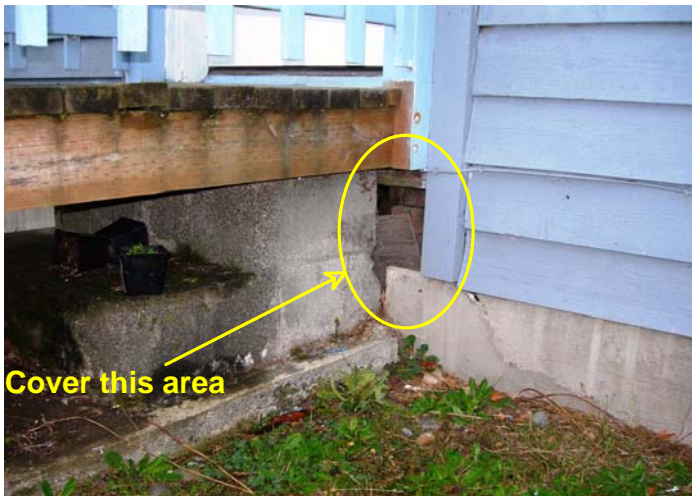
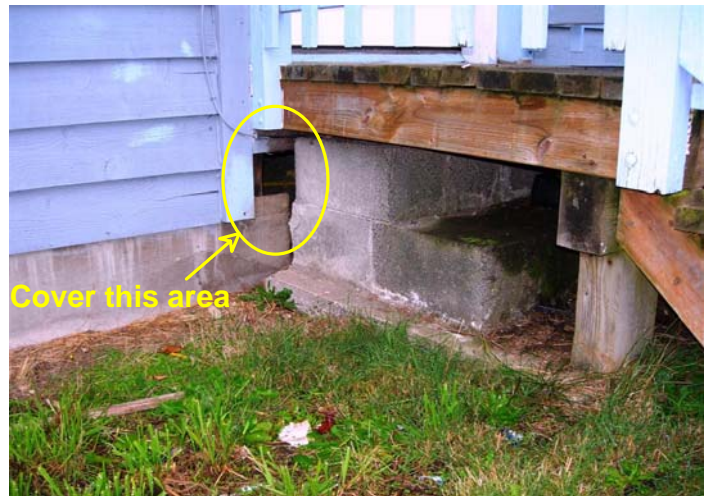
1.7 - Beneath the rear steps, a large hole through the foundation is allowing rodents and animals to enter the crawlspace. Recommend covering this area to prevent future entry by rodents and animals.

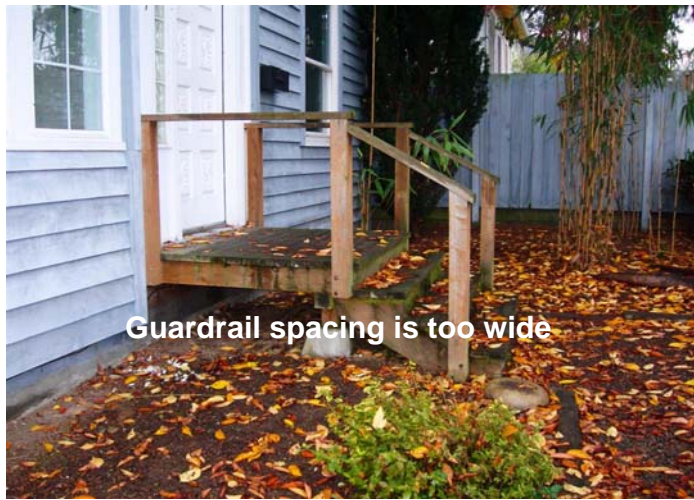
1.9 - The handrail on the front steps does not conform to today's safety standards. Common safety standards require that guardrail pickets should be no more than 4 inches apart and the top of the guardrail be a minimum of 34 inches and a maximum of 38 inches high. Recommend a qualified contractor upgrade this handrail for safety reasons.

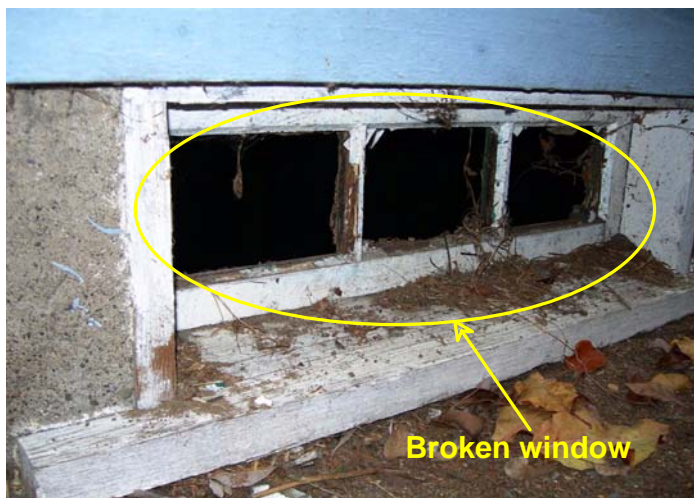
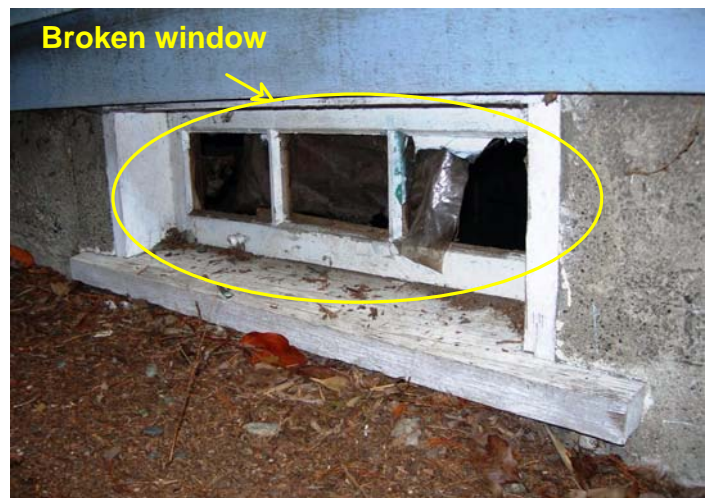
1.13 - On the west wall, the two windows in the crawlspace are broken and are allowing rodents and animals to enter the crawlspace. Recommend replacing the glass or installing a heavy gauge screen over the top of the openings.

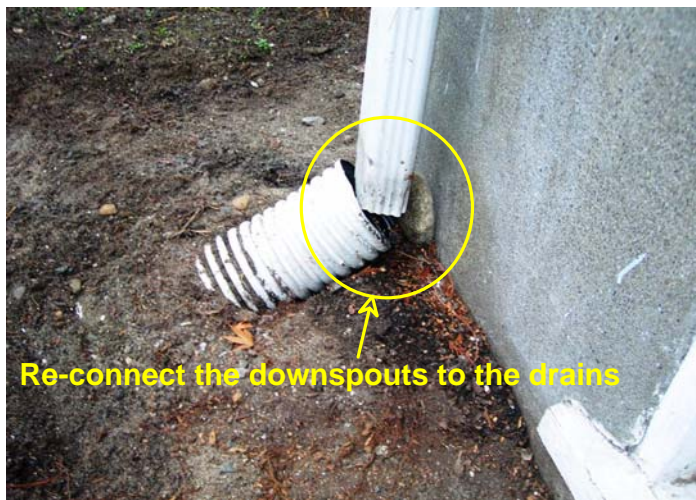
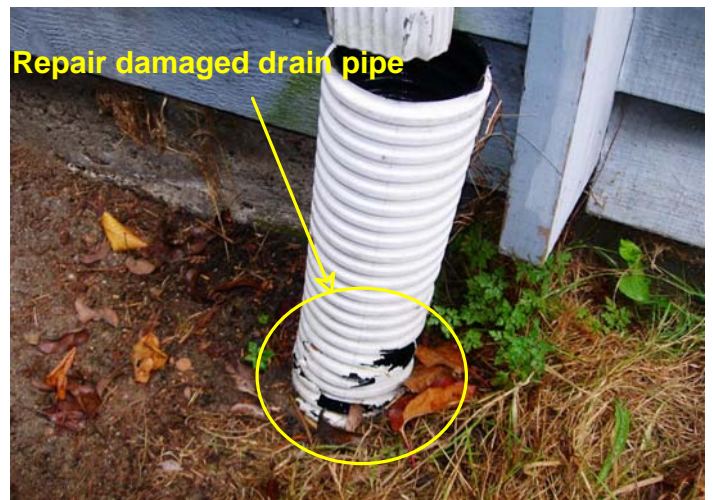
2.5 - Drainage is facilitated by the gutters discharging into underground drains. Although this system is very effective for diverting water away from the structure, its effectiveness depends on the gutters, downspouts and underground drains being kept clean and unobstructed.

Several of the downspouts on this house are not properly connected to the underground drains, and one underground drain pipe (at the SW corner of the house) is damaged. Recommend repairing the one damaged drain and re-connecting the downspouts to the drains properly.

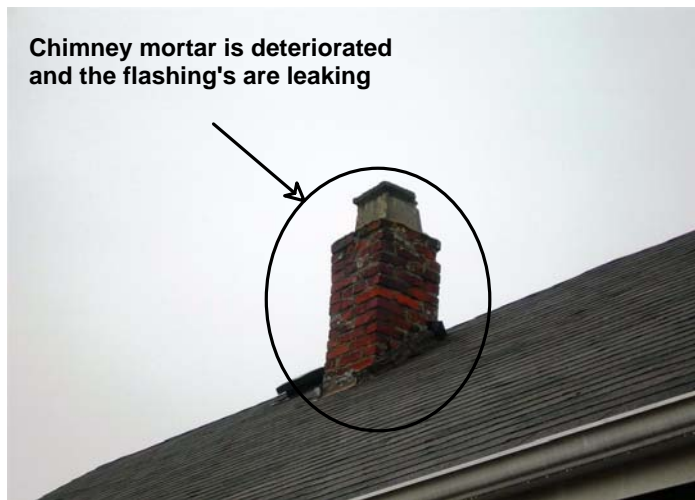
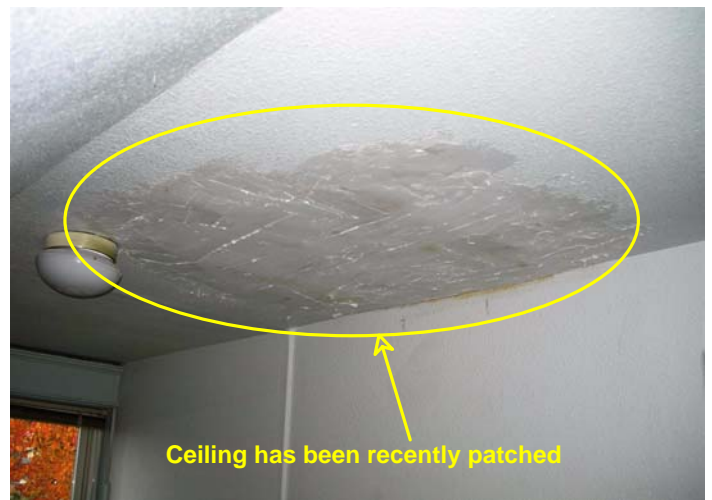
3.4 - There is no counterflashing between the chimney wall and the roof, and only mastic that must be kept sealed. There is a fresh patch in the ceiling of the upstairs bedroom next to the chimney, which indicates that the chimney flashings are leaking and damaging the ceiling materials. Recommend having a licensed roofing contractor install new chimney flashings and counterflashing on the chimney.

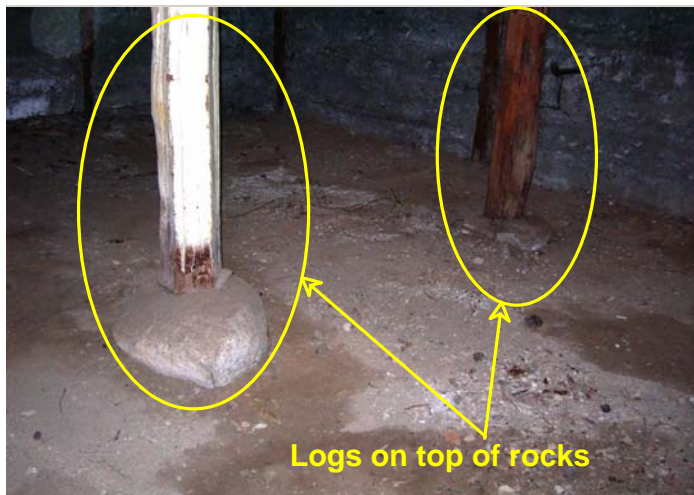
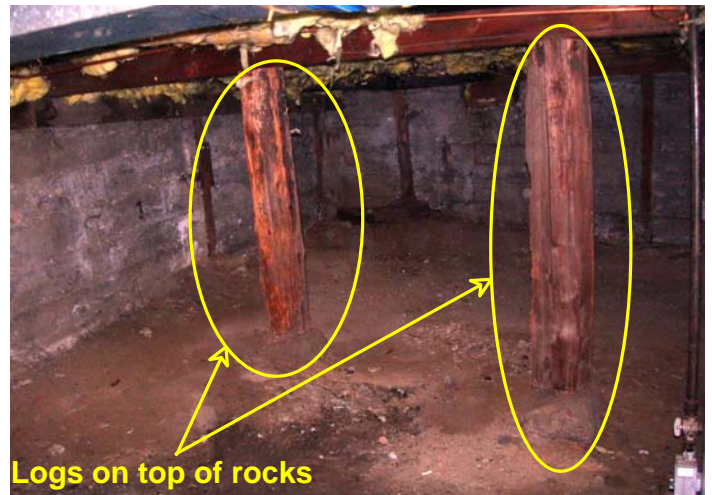
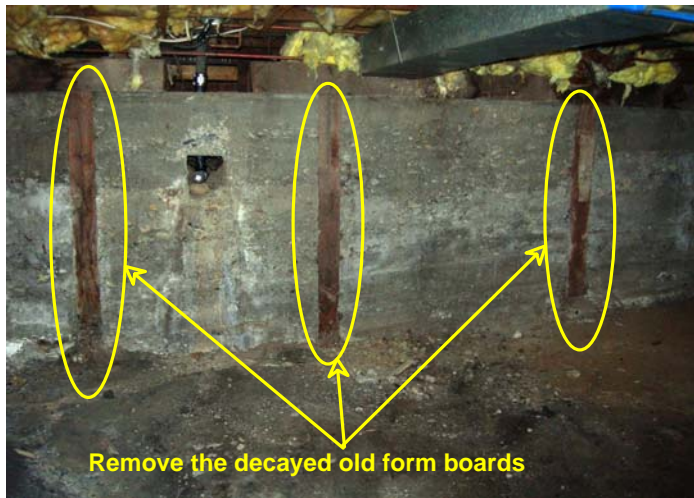
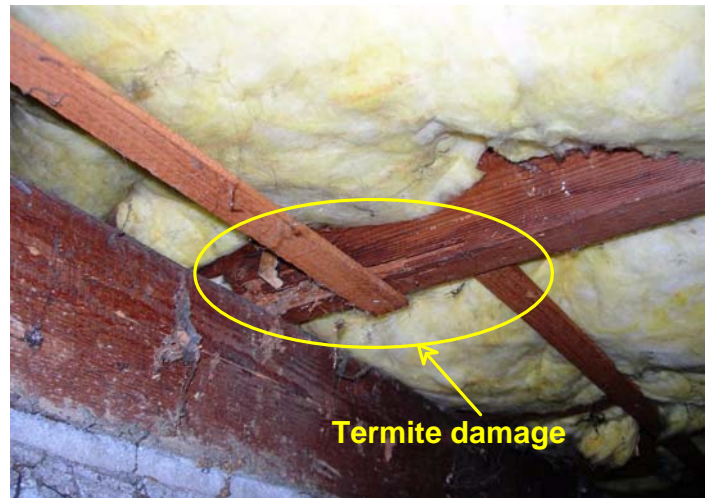
1) The support posts in the center of the crawlspace are old logs, which are supported by rocks sitting on the soil. This is inadequate and should be repaired. Recommend having a licensed contractor install concrete foundation footings and install new support posts.

3) The wood formboards embedded in the foundation walls are completely decayed and/or infested with wood destroying insects. Recommend removing all the old formboards that are embedded in the foundation walls.

4) In the southwest corner of the crawlspace, the large wood mud sill board on top of the foundation wall is infested with termites. One floor joist in this area is also completely infested and significantly damaged. Recommend having a contractor replace the infested mud sill board and the damaged floor joist.

5) The floor insulation limited visibility on the floor framing. Due to the termite activity seen in other wood materials in the crawlspace, we recommend having a licensed pest control operator treat the floor framing materials for termites.

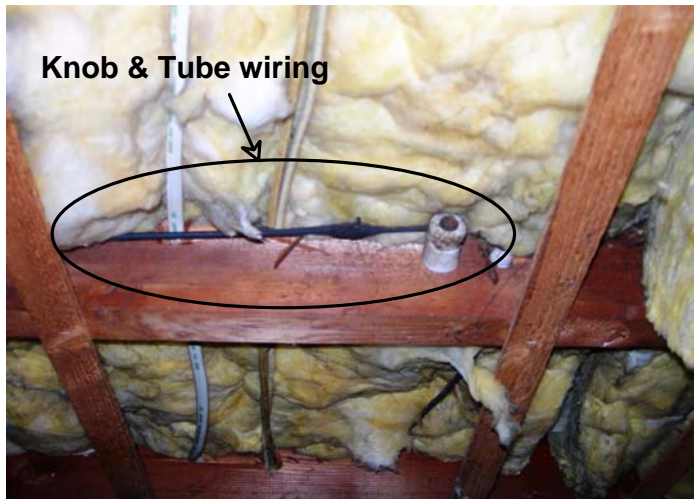
5.8 - Obsolete and suspect knob and tube wiring is present within the crawlspace, which should be replaced with new Romex wiring by a licensed electrician. The wire is very old and is buried in the insulation. This type of wire dissipates heat into the open air, so having the wire in contact with the insulation is considered a potential fire hazard.

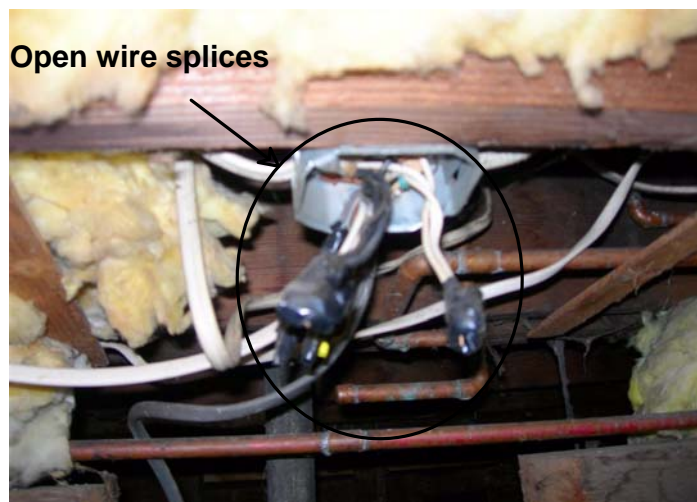
5.9 - Several electrical connections within the crawlspace have been improperly made outside of junction boxes. All such connections should be made within junction boxes in order to contain any arcing or sparking that could occur.

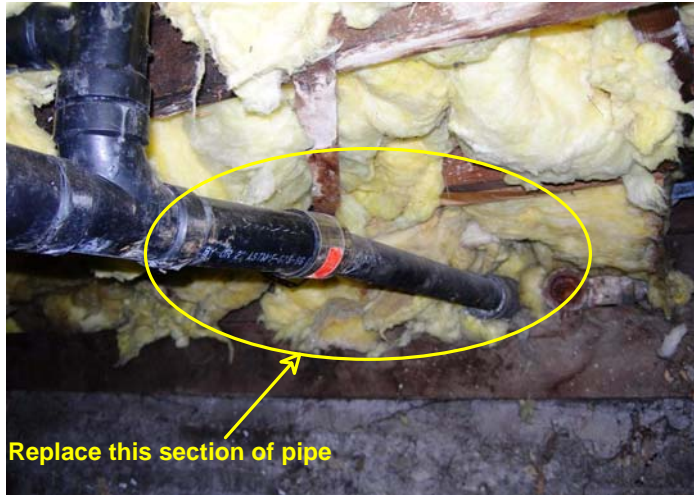
6.7 - The drain pipe that connects to the main drain at the rear of the crawlspace was not properly installed. The pipe is not sloped or sized properly. Recommend having a licensed plumber replace this section of plumbing drain pipe.

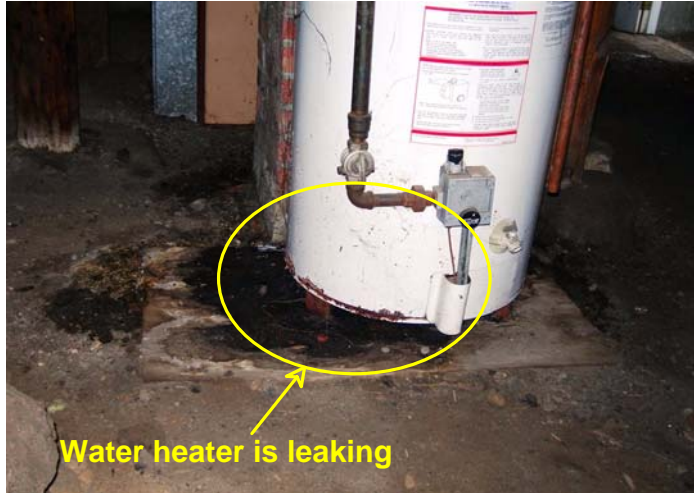
6.12 - Hot water is provided by a 19 year old, 50 gallon water heater that is located in the crawlspace. The base of the water heater is completely rusted and is leaking onto the ground. Recommend having a licensed plumber replace the water heater. The installation of a new water heater should be permitted and include proper earthquake strapping and an expansion tank.

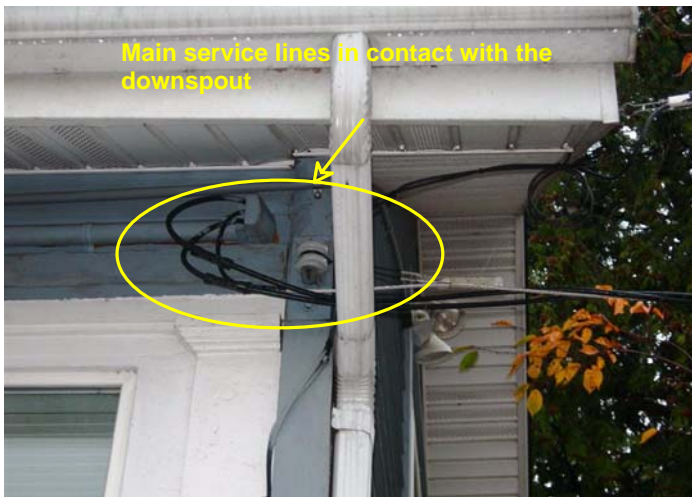
7.1 - The utility company's overhead conductor lines, which are attached to the side of the house, are in contact with the metal downspout. If the insulation gets worn on the wire, there is a possibility of the wires energizing the downspout. Recommend having a licensed electrician, in concert with the utility company, install a taller weathermast so that the service wire is not in contact with the downspout.

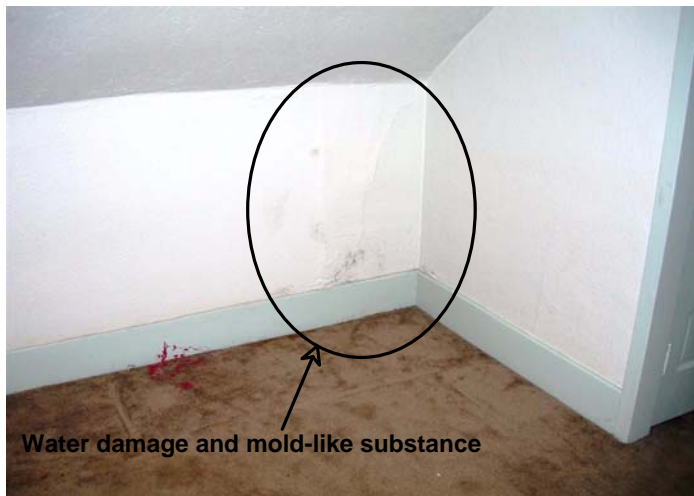
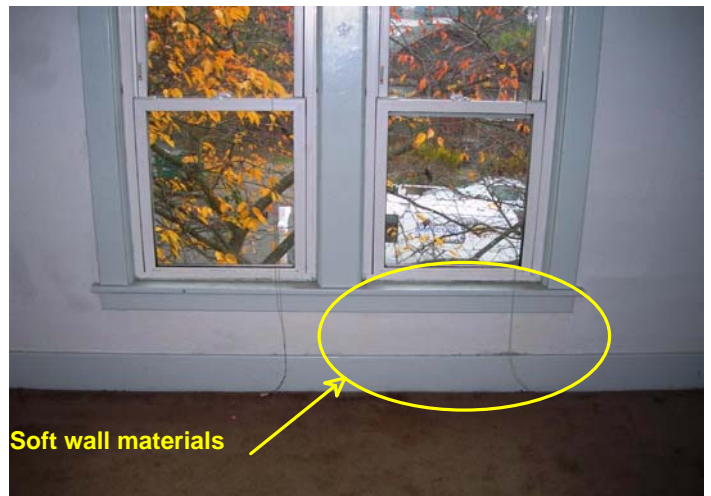
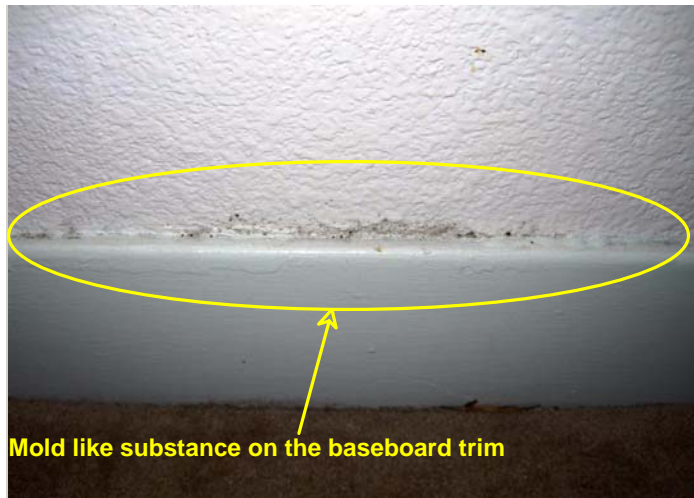
11.26 - A mold-like substance was observed on the east wall and the wall below the windows, which indicates possible water damage within the wall. The area below the windows also gives to gentle pressure. Recommend replacing all damaged wall materials in these areas. You can read more about mold and simple cleanup procedures by downloading the Environmental Protection Agency's "The homeowners brief guide to mold". This file can be downloaded from our website www.nwbuildinginspections.com

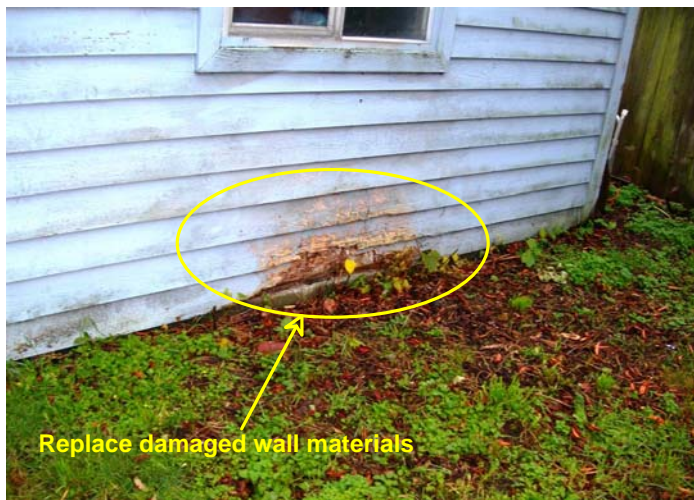
15.3 - Several wood studs show termite and carpenter ant damage. Recommend having a licensed pest control operator treat the garage studs for carpenter ant and termites.

15.4 - The siding on several large sections of the garage exterior is damaged and should be replaced.

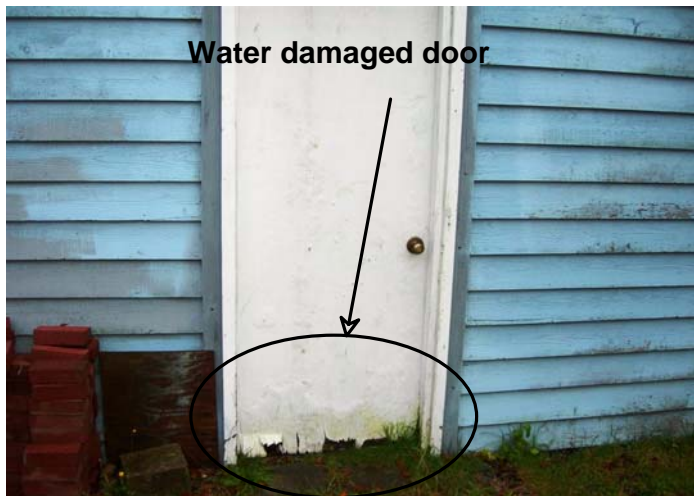
15.6 - The garage side door is moisture-damaged and delaminating, and should be replaced.

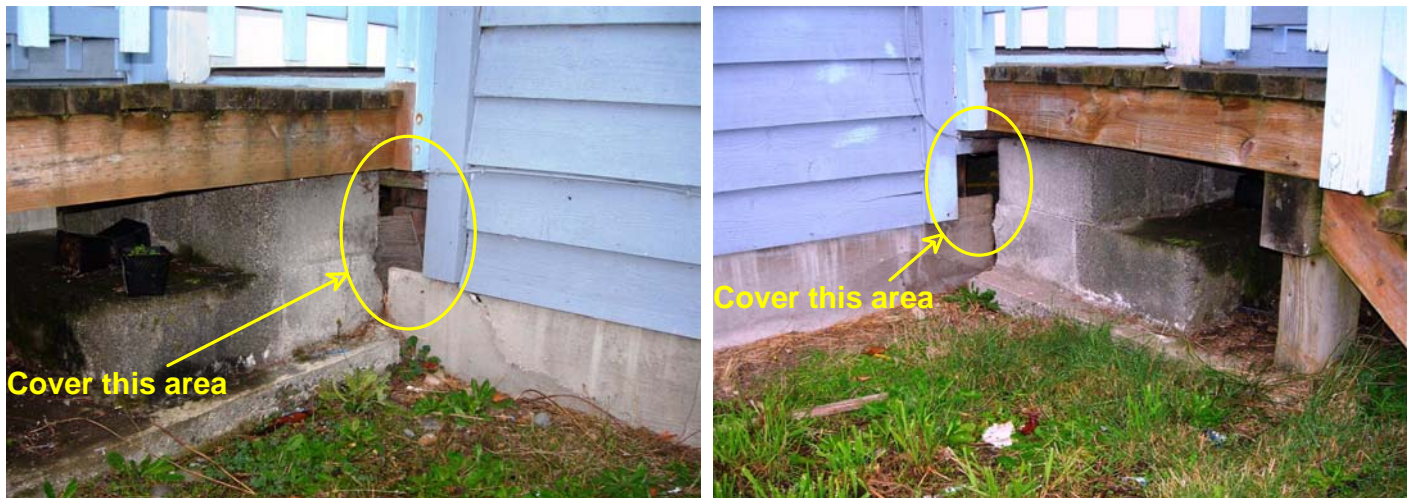
- 1.4 - Beneath the rear steps, a large hole through the foundation is allowing rodents and animals to enter the crawlspace. Recommend covering this area to prevent future entry by rodents and animals.

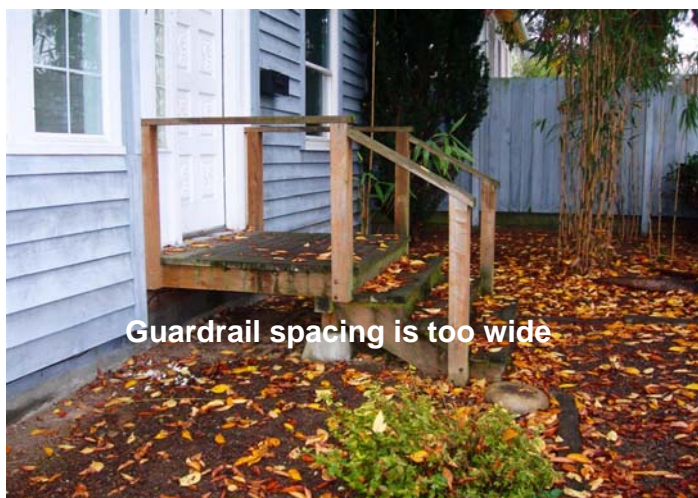
- 1.5 - The handrail on the front steps does not conform to today's safety standards. Common safety standards require that guardrail pickets should be no more than 4 inches apart and the top of the guardrail be a minimum of 34 inches and a maximum of 38 inches high. Recommend a qualified contractor upgrade this handrail for safety reasons.

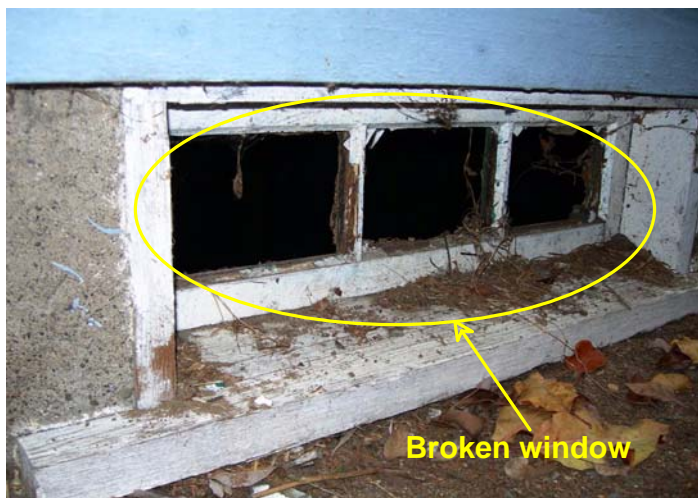
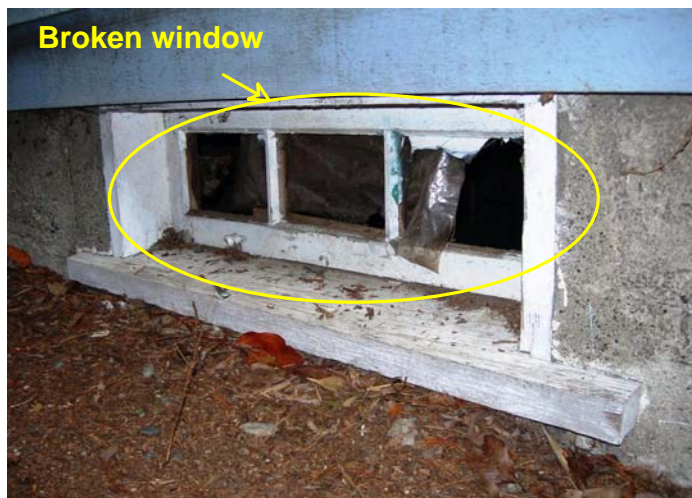
1.7 - On the west wall, the two windows in the crawlspace are broken and are allowing rodents and animals to enter the crawlspace. Recommend replacing the glass or installing a heavy gauge screen over the top of the openings.

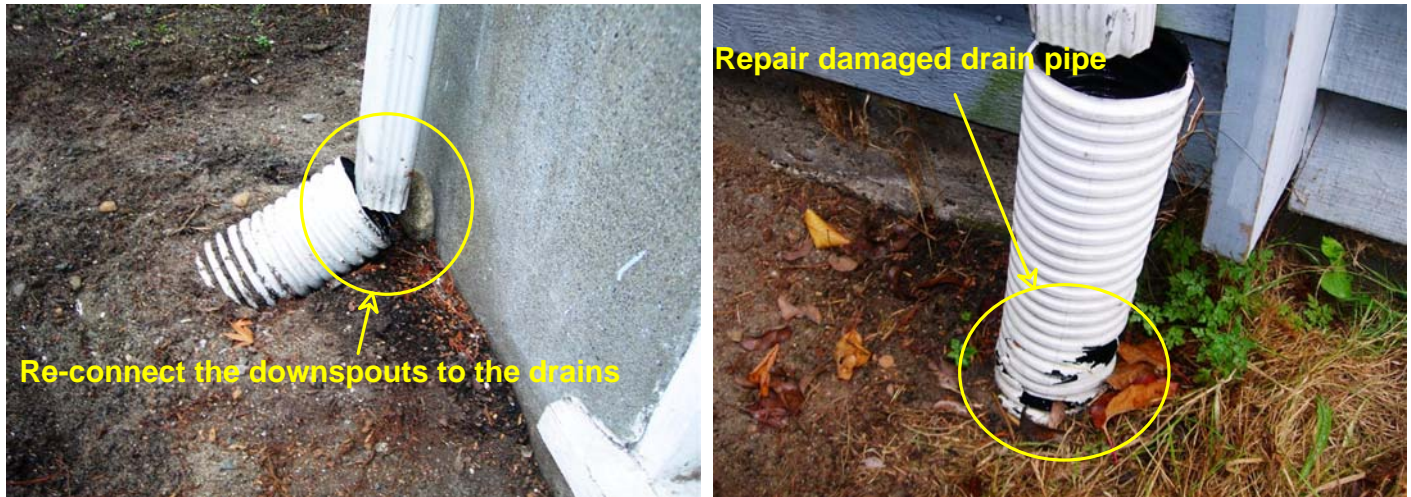
2.2 - Drainage is facilitated by the gutters discharging into underground drains. Although this system is very effective for diverting water away from the structure, its effectiveness depends on the gutters, downspouts and underground drains being kept clean and unobstructed.

Several of the downspouts on this house are not properly connected to the underground drains, and one underground drain pipe (at the SW corner of the house) is damaged. Recommend repairing the one damaged drain and re-connecting the downspouts to the drains properly.

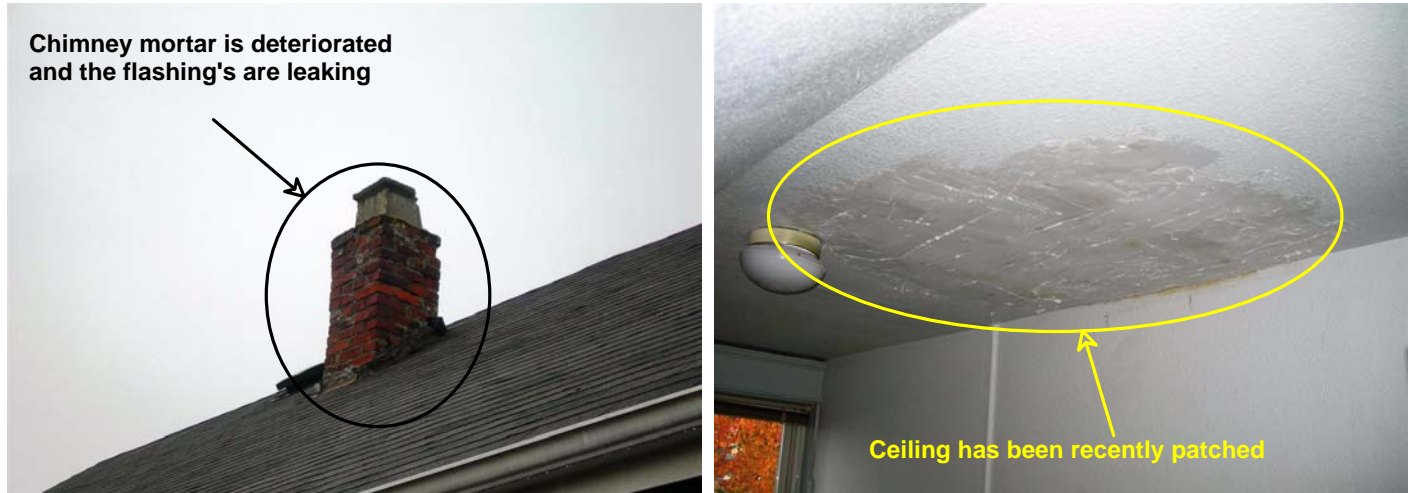
- 3.4 - There is no counterflashing between the chimney wall and the roof, and only mastic that must be kept sealed. There is a fresh patch in the ceiling of the upstairs bedroom next to the chimney, which indicates that the chimney flashings are leaking and damaging the ceiling materials. Recommend having a licensed roofing contractor install new chimney flashings and counterflashing on the chimney.

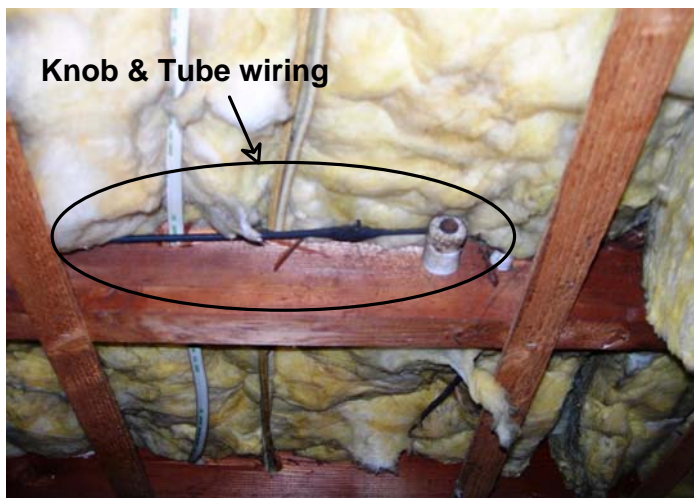
- 5.5 - Obsolete and suspect knob and tube wiring is present within the crawlspace, which should be replaced with new Romex wiring by a licensed electrician. The wire is very old and is buried in the insulation. This type of wire dissipates heat into the open air, so having the wire in contact with the insulation is considered a potential fire hazard.

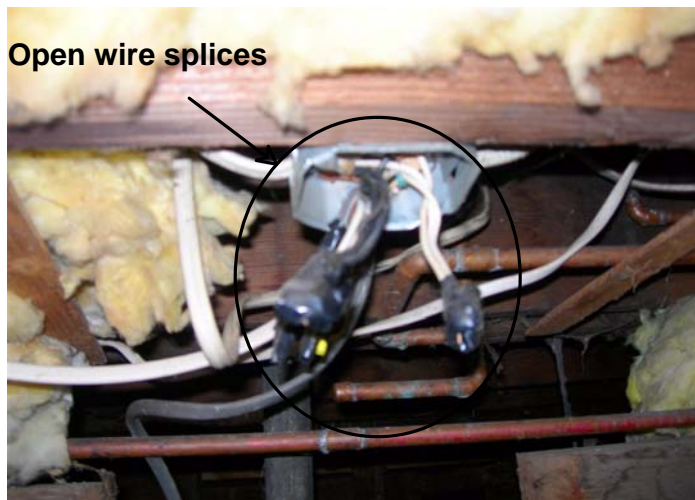
- 5.6 - Several electrical connections within the crawlspace have been improperly made outside of junction boxes. All such connections should be made within junction boxes in order to contain any arcing or sparking that could occur.

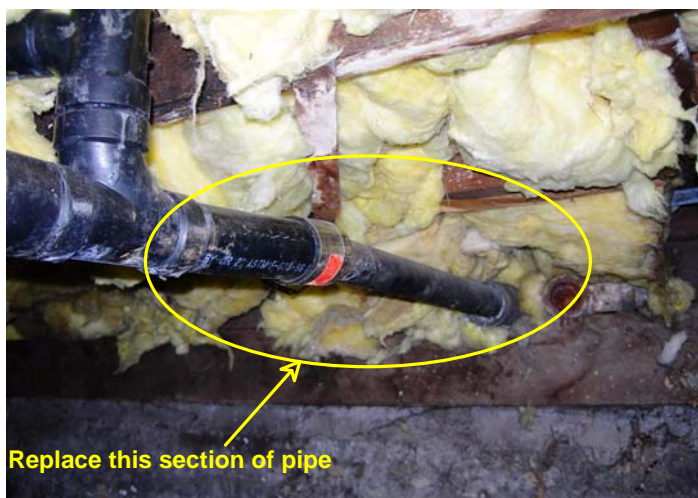
- 6.4 - The drain pipe that connects to the main drain at the rear of the crawlspace was not properly installed. The pipe is not sloped or sized properly. Recommend having a licensed plumber replace this section of plumbing drain pipe.

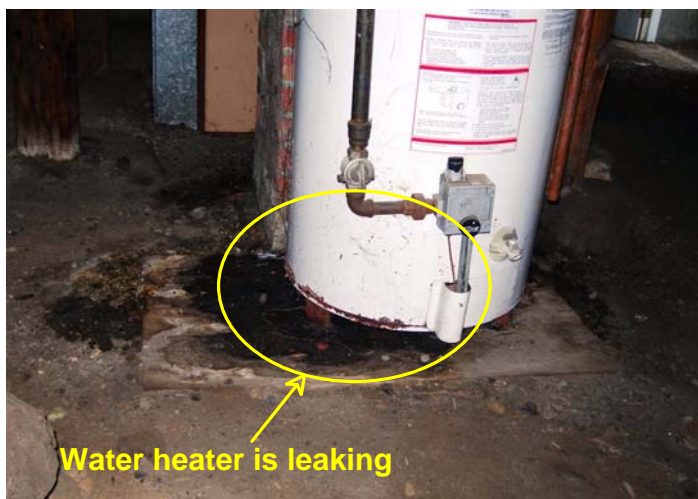
6.7 - Hot water is provided by a 19 year old, 50 gallon water heater that is located in the crawlspace. The base of the water heater is completely rusted and is leaking onto the ground. Recommend having a licensed plumber replace the water heater. The installation of a new water heater should be permitted and include proper earthquake strapping and an expansion tank.

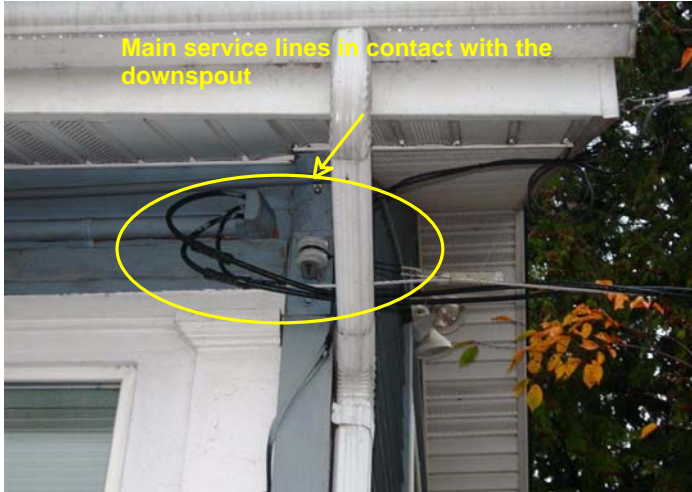
- 7.1 - The utility company's overhead conductor lines, which are attached to the side of the house, are in contact with the metal downspout. If the insulation gets worn on the wire, there is a possibility of the wires energizing the downspout. Recommend having a licensed electrician, in concert with the utility company, install a taller weathermast so that the service wire is not in contact with the downspout.

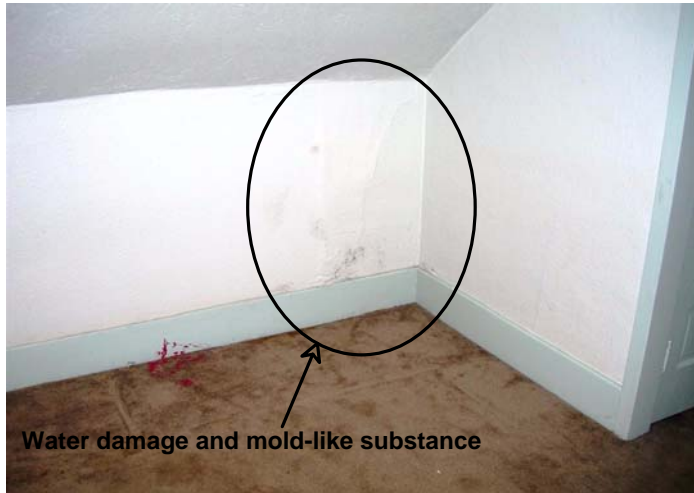
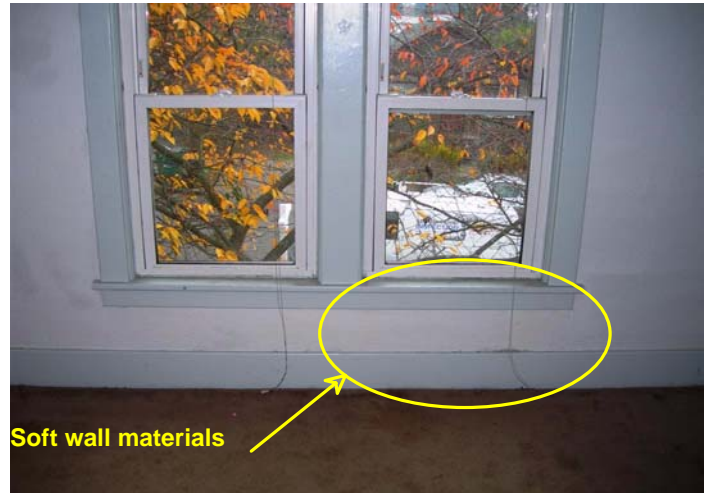
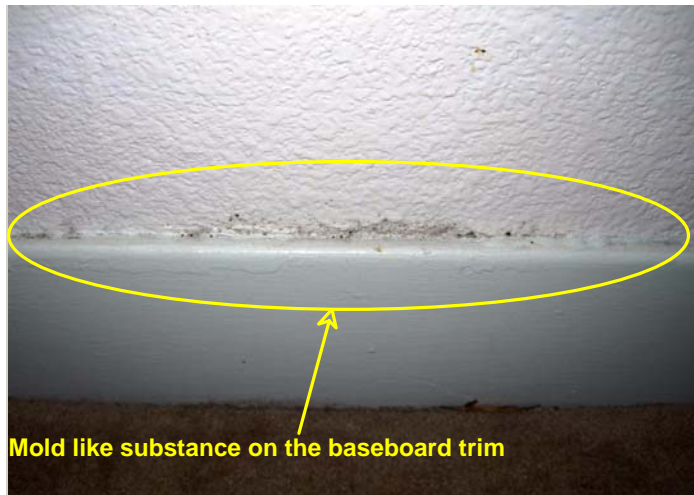
11.4 - A mold-like substance was observed on the east wall and the wall below the windows, which indicates possible water damage within the wall. The area below the windows also gives to gentle pressure. Recommend replacing all damaged wall materials in these areas. You can read more about mold and simple cleanup procedures by downloading the Environmental Protection Agency's "The homeowners brief guide to mold". This file can be downloaded from our website www.nwbuildinginspections.com

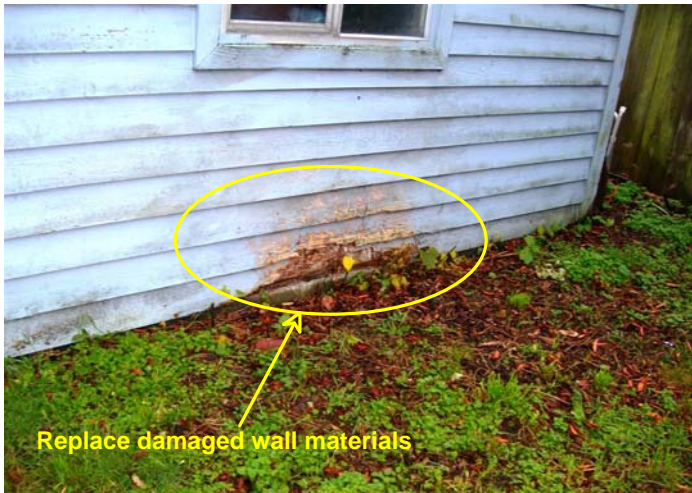
15.1 - Several wood studs show termite and carpenter ant damage. Recommend having a licensed pest control operator treat the garage studs for carpenter ant and termites.

15.2 - The siding on several large sections of the garage exterior is damaged and should be replaced.

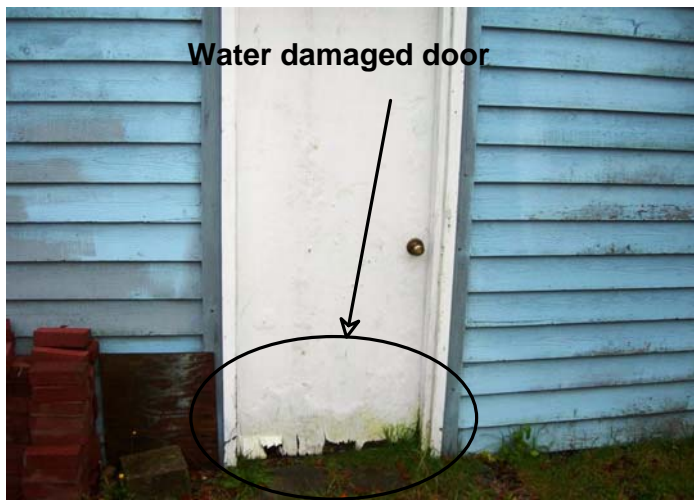
15.3 - The garage side door is moisture-damaged and delaminating, and should be replaced.
