EIFS INSPECTION REPORT

Date: xx/xx/2007

Inspection Address: 1234 51st ST Ct, Mill Creek, WA 98012

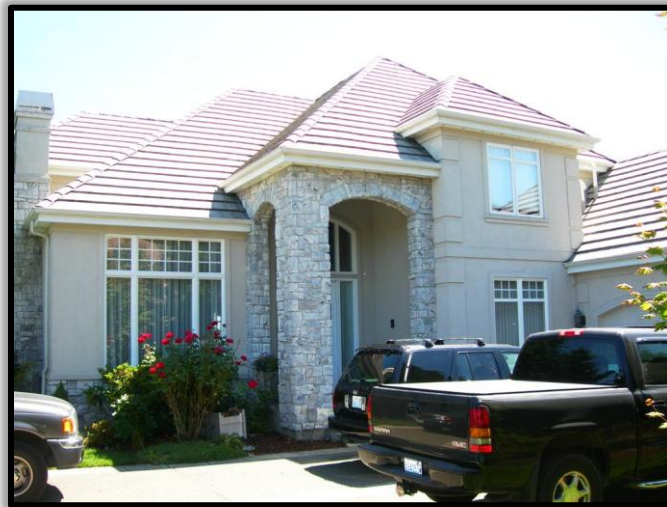
This house was built in 1994, and the EIFS is original. The house is clad with EIFS on all four sides. The system appears to be a barrier-style EIFS and the manufacturer is Dryvit. With the exception of a few noted areas, the cladding on the house is in acceptable condition at this time. However, the system was not installed according to manufacturer's instructions. Therefore, there is greater potential for this system to experience problems associated with water leakage in the future.
