## **PROPERTY CONDITION ASSESSMENT**

**Date:** xx/xx/2007

**Inspection Address:** 1234 51<sup>st</sup> ST Ct, Mill Creek, WA 98012

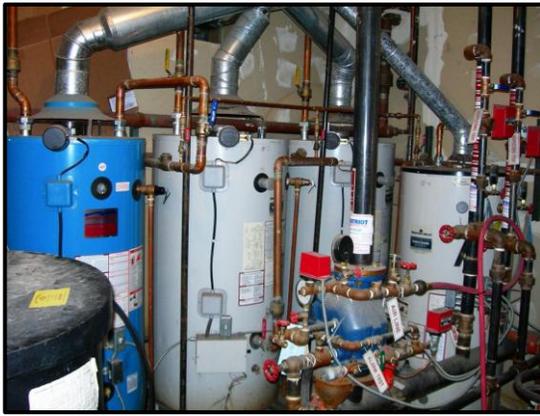
Year	Size	Location	Condition
2005	100 gallon	Laundry Room	Acceptable
1996	100 gallon	Laundry Room	Acceptable (mid-span in useful life)
1996	100 gallon	Laundry room	Leaking and needs to be replaced
1996	75 gallon	Laundry room	Acceptable (mid-span in useful life)

General view of the water heaters
